MARINE GAS TURBINE HOT CORROSION
DEPENDENCE ON INGESTED SALT LEVELS

Report No. FR-11544

R.H. Barkalow and F.S. Pettit
United Technologies Corporation
Pratt & Whitney Aircraft Group
Government Products Division
West Palm Beach, FL 33402

16 April 1979

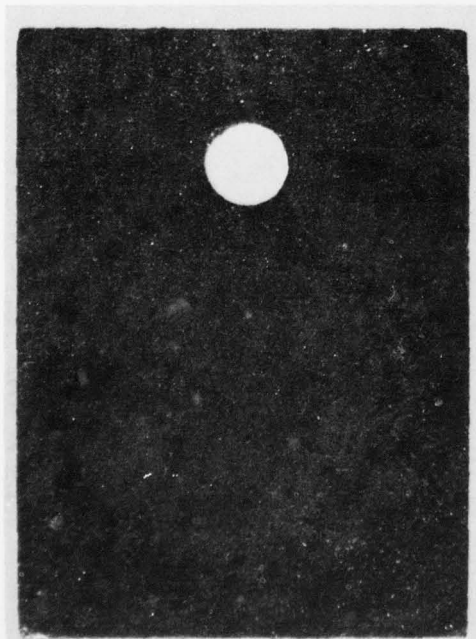
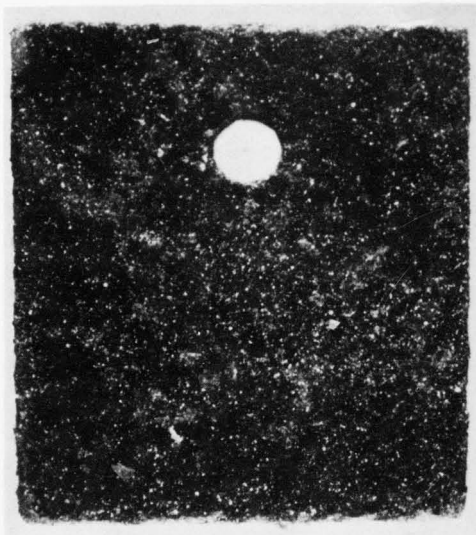
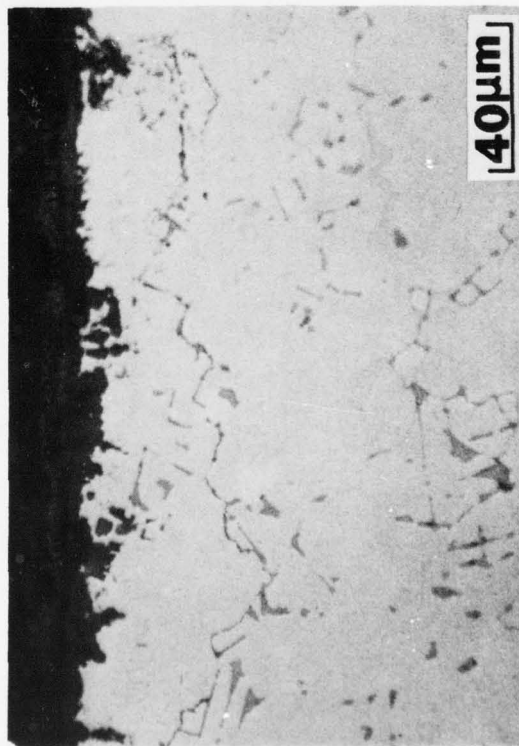
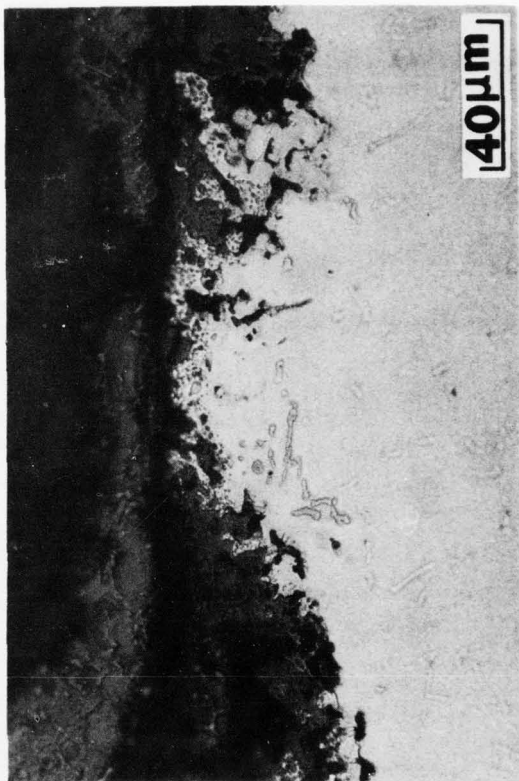
a. Chloride-free air

b. Air with 300 ppm NaCl vapor

Figure 32. Effect of chloride vapor on sulfate-induced hot corrosion of uncoated Mar-M509. Specimens were exposed under identical conditions (200 hours at 899C, 1 mg/cm² Na₂SO₄ salt deposit) except for chloride-free air versus 300 ppm NaCl vapor in the furnace atmosphere.

Uncoated Mar-M509 was substantially more degraded in the experiment with NaCl vapor (Figure 32). The effect is believed to be real, although the relatively slight degradation of the specimen tested in air is of questionable reproducibility and the chloride effect might not be as pronounced as the results of these two experiments suggest. For the Co-base coatings, observation of a number of randomly selected areas on the entire cross section would support the conclusion that degradation was slightly greater due to the NaCl vapor, especially for the aluminized Mar-M509. The CoCrAlY coatings were only lightly attacked in both tests and the difference might have been within experimental scatter.

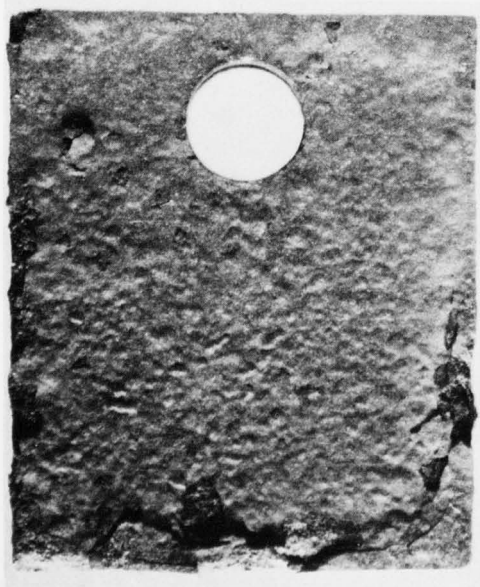
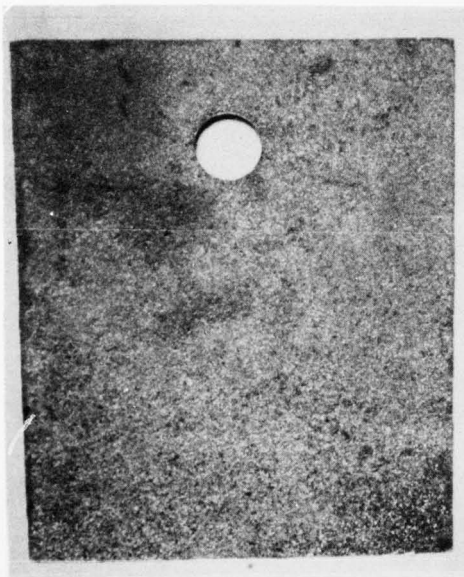
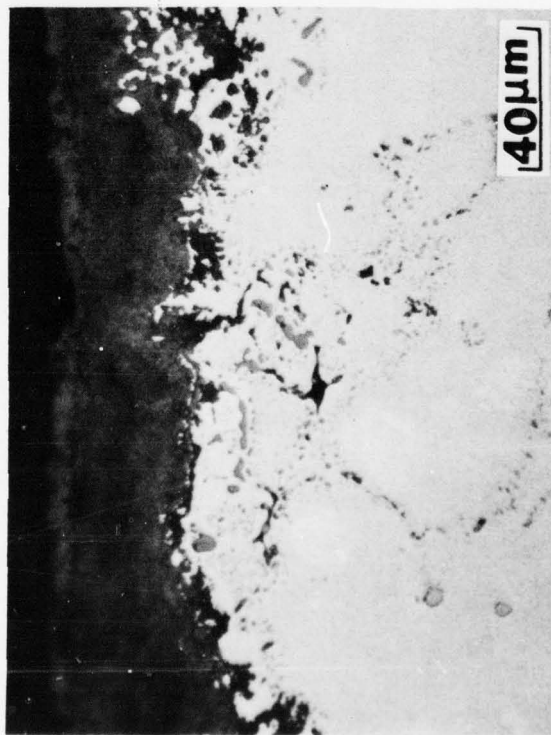
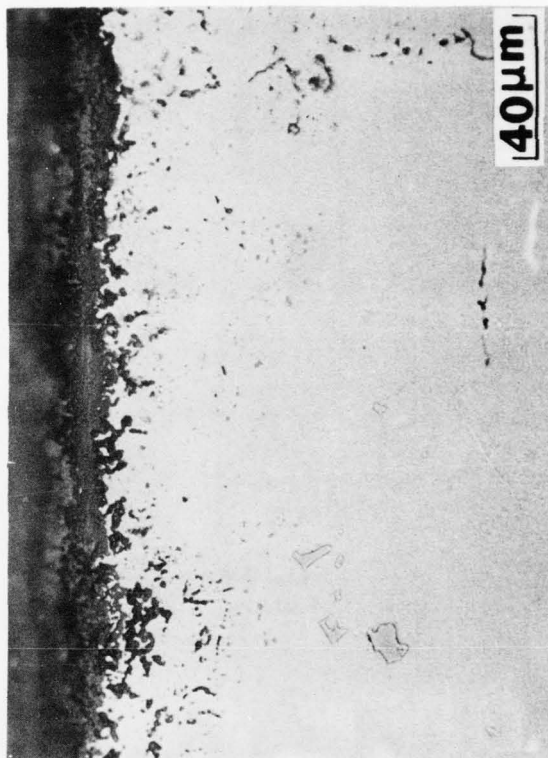
a. Chloride-free air

b. Air with 300 ppm NaCl vapor

Figure 33. Effect of chloride vapor on sulfate-induced hot corrosion of uncoated IN 792. Specimens were concurrently tested with those of Fig. 32.

The concurrently exposed Ni-base alloys were less corroded in the chloride-containing atmosphere, as shown in Figure 33 by surface condition and metallography of uncoated IN 792. Visual inspection of the aluminized sample indicated minimal attack except for a massive edge failure which is not attributed to the chloride vapor; post-test metallography confirmed minimal microstructural degradation except for cut-edge attack.

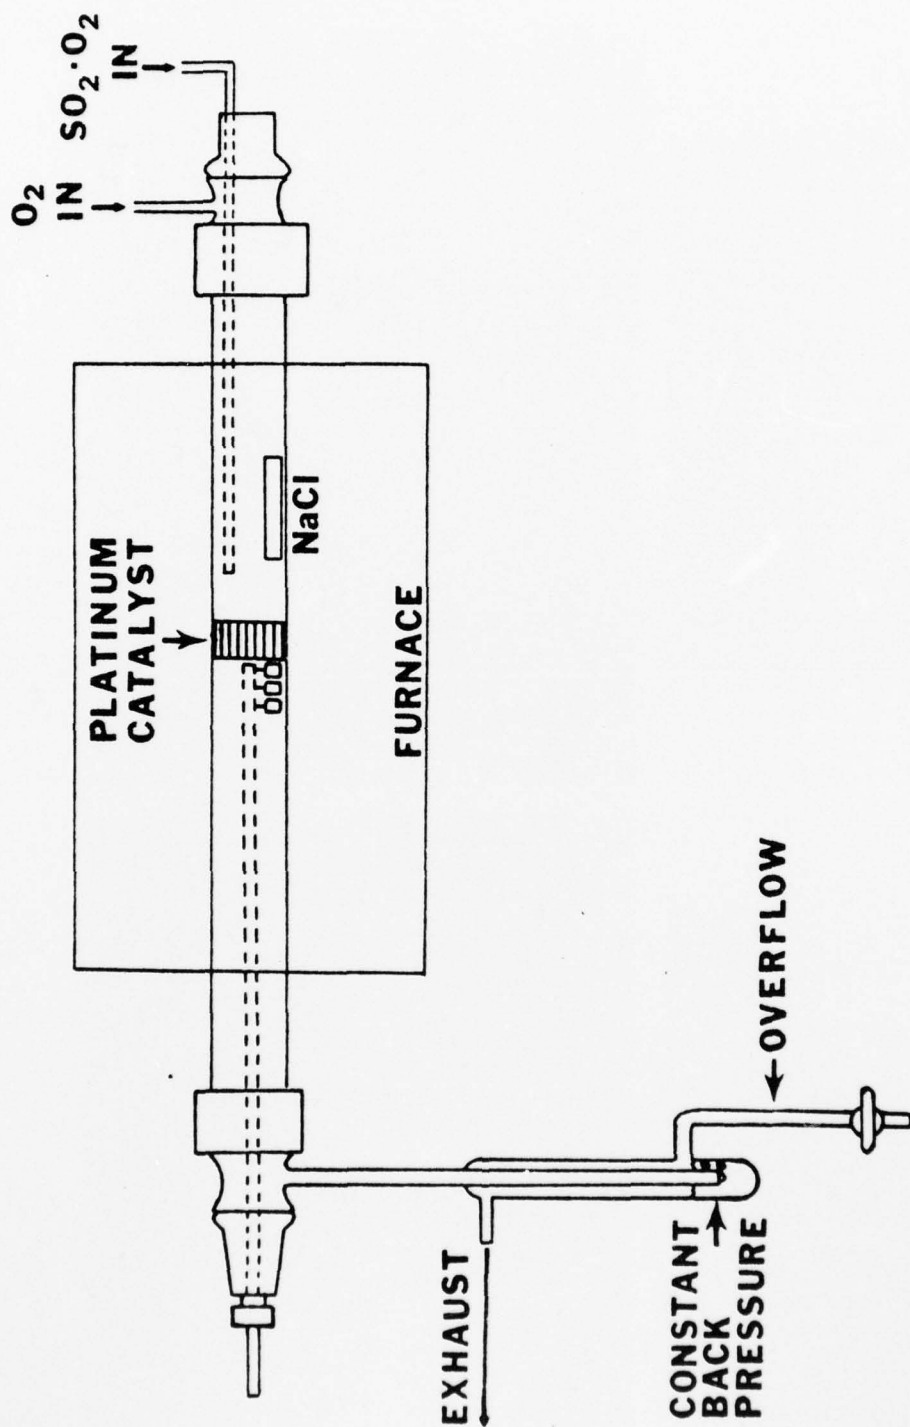
Figure 34. Schematic diagram of horizontal tube furnace for hot corrosion testing with both SO_3 gas and NaCl vapor in the atmosphere. Apparatus is the same as that in Figure 2 except for the separate input of oxygen and $SO_2 \cdot O_2$, which is necessary to avoid reaction of the SO_2 with solid NaCl prior to reaching the catalyst and the specimens.

The horizontal tube furnace described in Section 1 was modified as shown in the sketch of Figure 34 to permit exposure of the test specimens to both SO_3 and NaCl vapor. Gas flow rates and $\text{SO}_2:\text{O}_2$ input ratios were the same as those of the preceding experiments with SO_3 gas, but it was necessary to introduce the SO_2 down stream of the NaCl boat to prevent consumption of the SO_2 via reaction with the solid NaCl. Tests were run at an SO_3 pressure of 0.0007 atm, since degradation produced by this concentration was known to be substantial but not sufficiently catastrophic to overwhelm a possible effect of the chloride. A chloride vapor concentration of 30 ppm - maintained by heating the NaCl to 677°C (1250°F) - was arbitrarily selected.

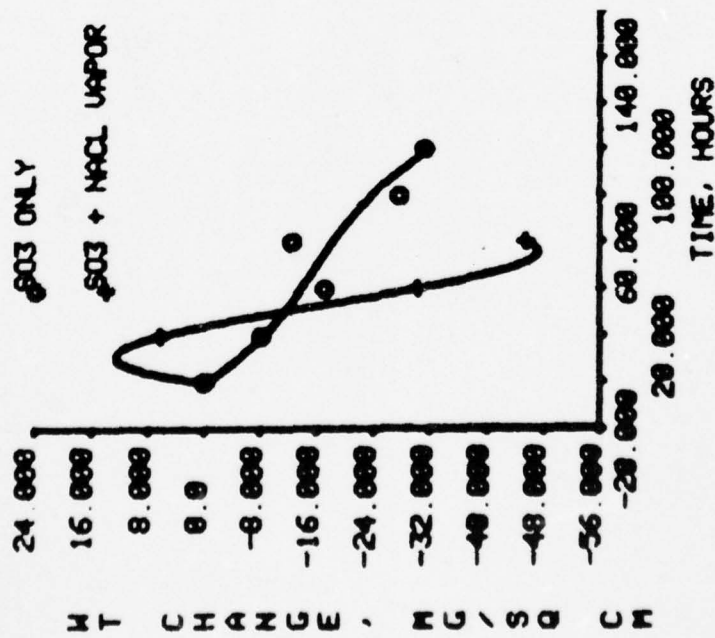
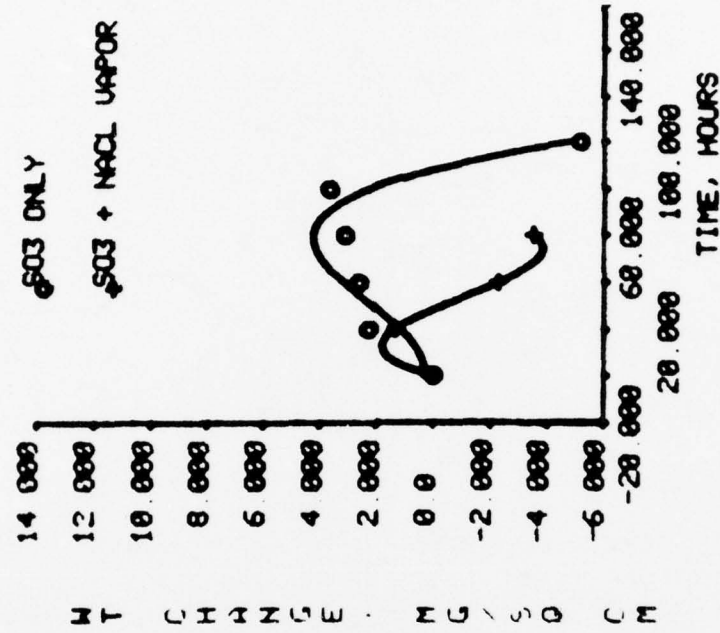
a. Mar-M509

b. Aluminized IN 792

Figure 35. Weight change data for uncoated Mar-M509 and aluminized IN 792 in SO₃ and SO₃ + NaCl atmospheres (704C, P_{SO₃} = 0.0007 atm, NaCl vapor concentration = 30 ppm).

Visual inspection after the initial 20-hour exposure cycle suggested increased attack of all of the specimens except the uncoated Mar-M509, although the effect was not dramatic. After 60 hours, consistently larger weight losses of Mar-M509 and aluminized IN 792 (Figure 35) apparently reflect increased scale spallation due to the chloride. Weight changes of the other test materials were not significantly different in chloride-containing versus chloride-free atmospheres.

Such an effect, if present, would almost surely have caused a substantially increased degradation rate of the samples in Figures 35 to 40, where a relatively high SO_3 pressure and a relatively high concentration of NaCl vapor left microstructural features characteristic of both processes. Indeed, as mentioned in presenting the results, the degradation of several of the specimens did appear greater than in the corresponding test at the same SO_3 pressure but without chloride vapor. However the difference was probably within experimental scatter, or at most could be considered an additive effect of increased scale spallation and SO_3 -induced attack. The depth of attack in no case was significantly greater than that attributable to the SO_3 pressure alone.

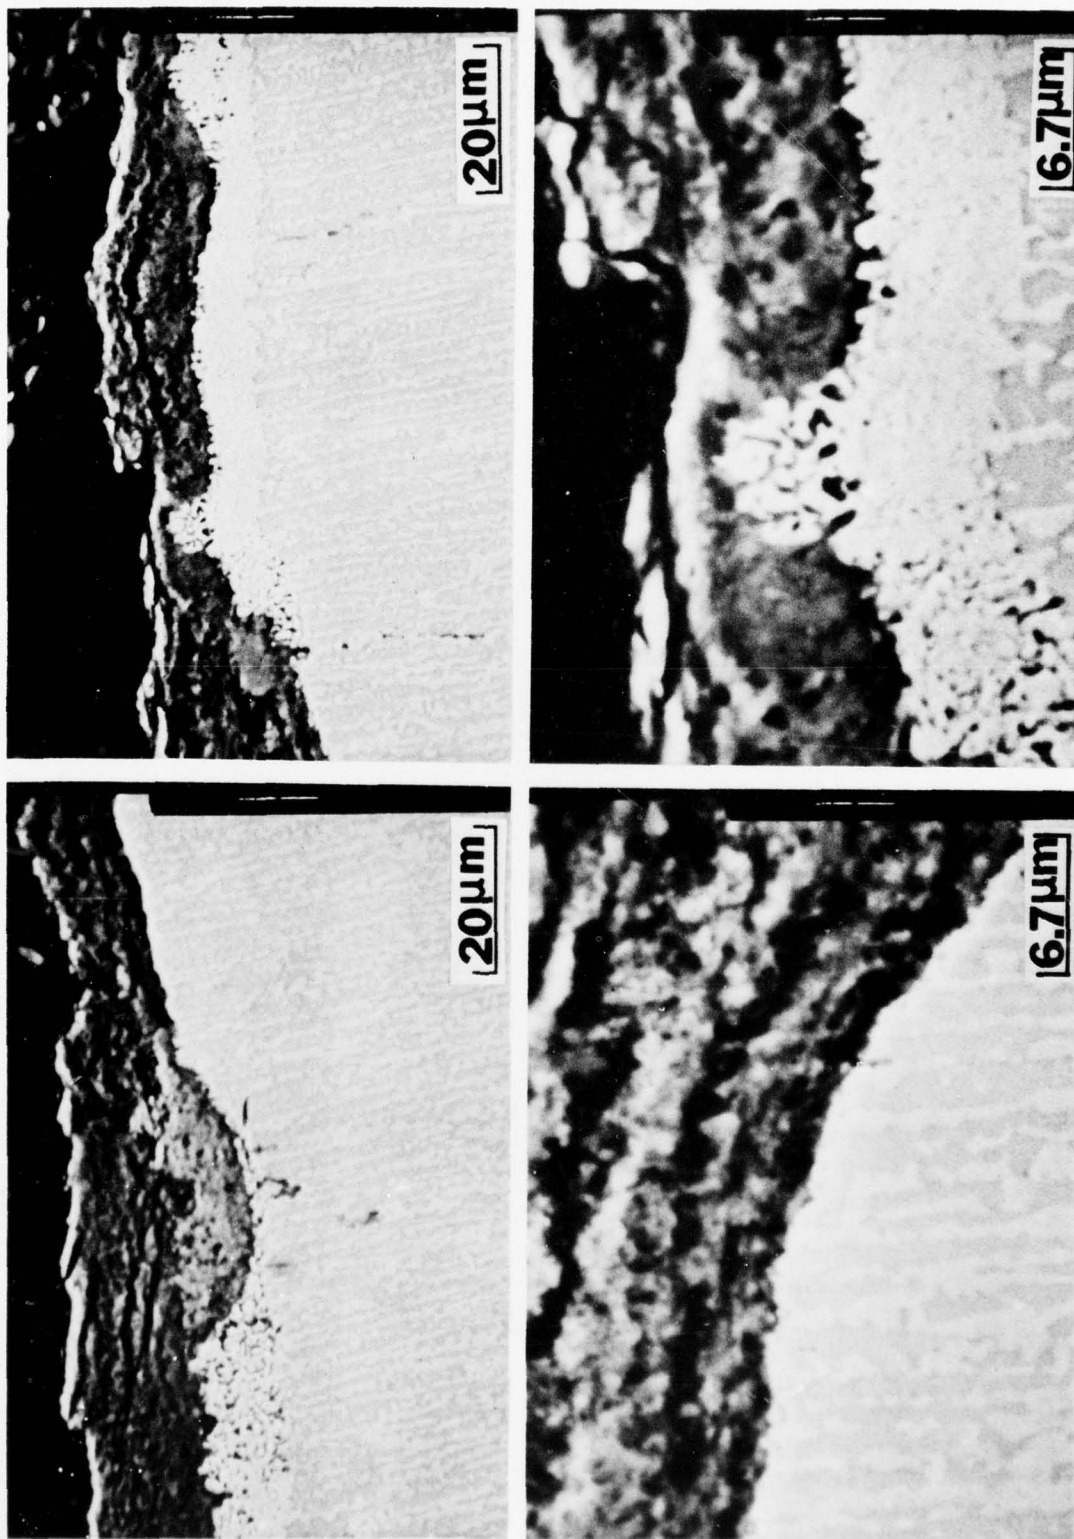
Figure 36. Microstructures of PWA 68 CoCrAlY coating tested at 704C with simultaneous presence of gaseous SO_3 (0.0007 atm) and NaCl vapor (30 ppm). Note characteristic morphology of both SO_3 - and NaCl-induced hot corrosion in randomly selected areas of the attack front.

Post-test metallography showed an unusual superposition of microstructural features characteristic of low temperature SO_3 -induced attack and chloride-induced dealloying. The mixed microstructure was especially prevalent in the CoCrAlY coating, where adjacent areas showed a sharp transition between the complete absence of internal oxidation typical of SO_3 effects and the substantial dealloying and pore formation typical of chloride corrosion (Figure 36). Areas with the SO_3 -type morphology were also characterized by sulfur in the scale (Figure 37a, 37b); other areas showed variations in the composition and ghost microstructure of the scale which suggested that attack may have oscillated between SO_3 - and chloride-type (Figure 37c).

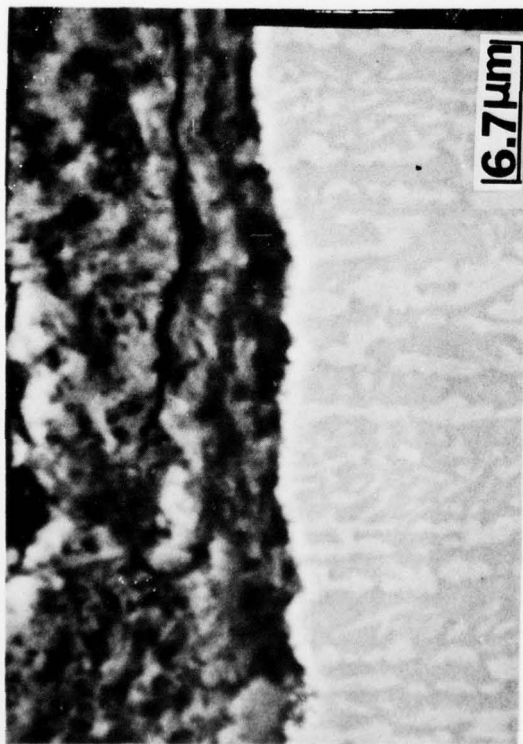
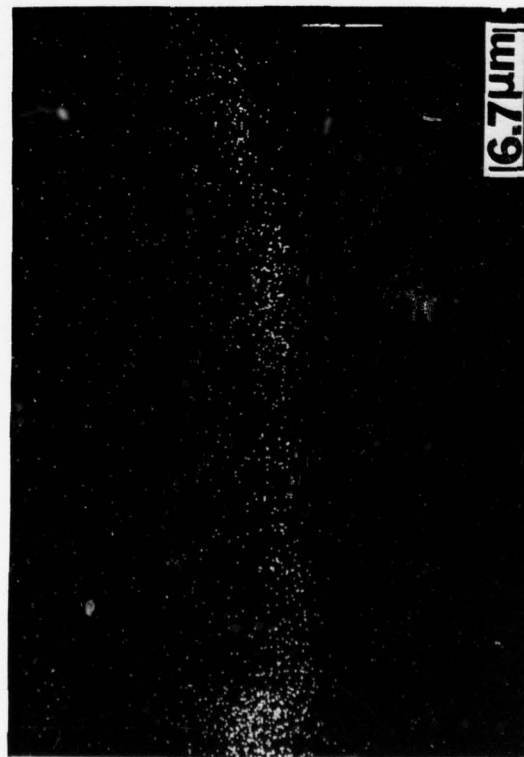
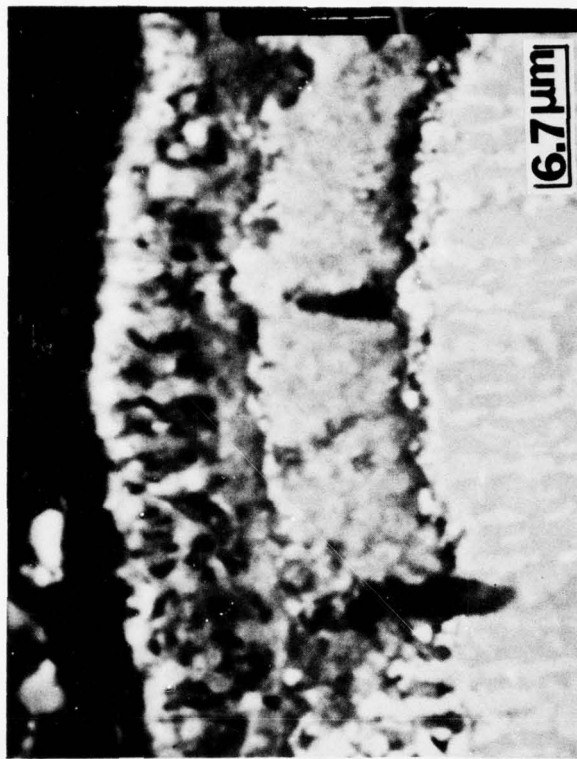
a. SO_3 -type morphology of attack front (i.e. no diffusion zone or internal oxidation).

b. Sulfur X-ray image of above area

c. Variable composition (indicated by different contrast in back scattered electron image) and morphology of scale

Figure 37. Sulfur-containing scale in area showing SO_3 -type morphology of attack front (a and b); variation in composition and morphology of scale, possibly indicating attack mechanism oscillating between SO_3 - and chloride-type corrosion.

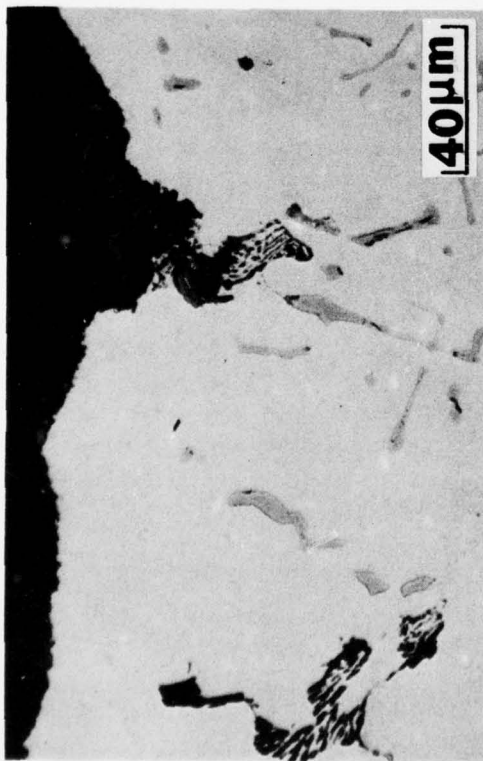
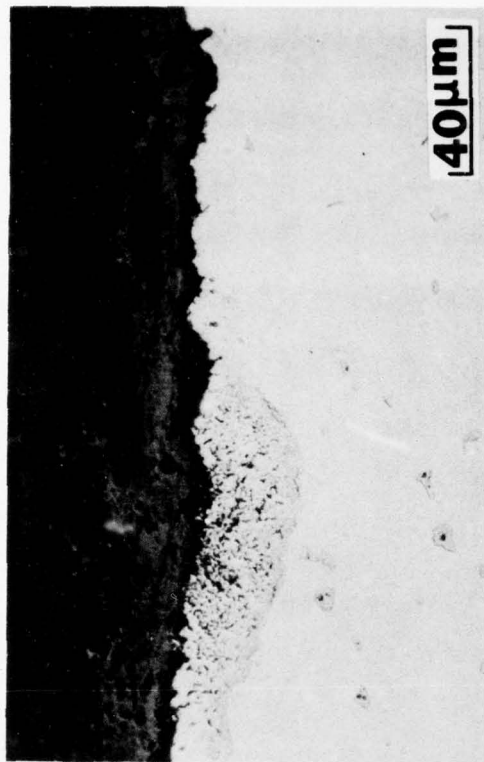
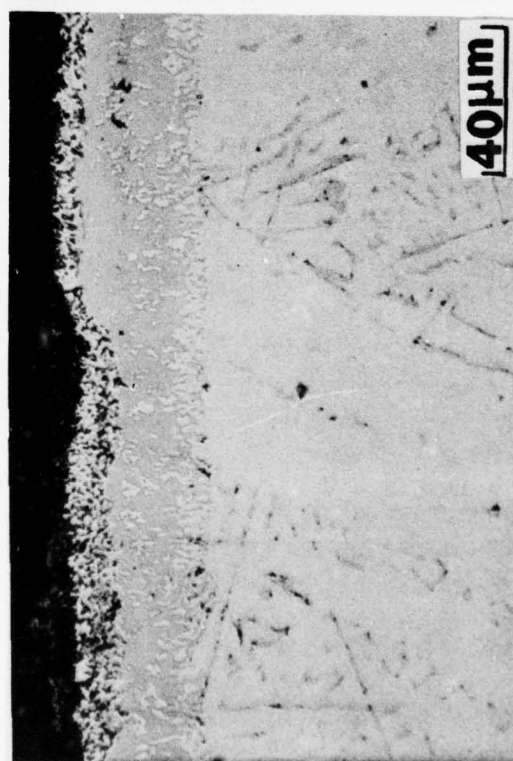
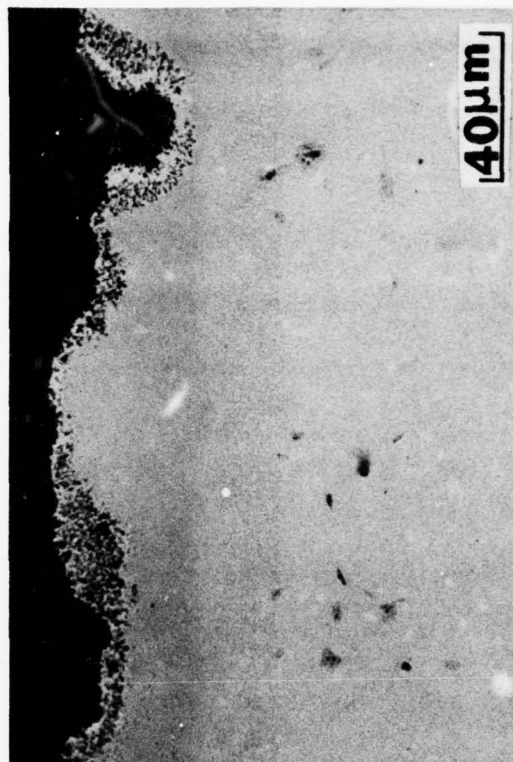
38a. Uncoated Mar-M509

38b. Uncoated IN 792

38c. Mar-M509/FWA 28 aluminide

38d. IN 792/FWA 273 aluminide

Figure 38. Uncoated and aluminized alloys tested concurrently with the CoCrAlY coating of Figs. 36 and 37 (i.e. 60 hours at 704C, $PSO_3 = 0.0007$ atm, 30 ppm NaCl vapor)

In the case of the other test materials, microstructural effects of the chloride vapor were not evident in Mar-M509 (Figure 38a), although the concurrently tested IN 792 (Figure 38b) exhibited many areas of internal oxidation (arrow) which were not observed in degradation microstructures produced by SO_3 only. Both aluminide coatings showed a more or less uniform microstructure of the attack front with chloride-type dealloying and internal oxidation proceeding the nodular attack typical of SO_3 (Figures 38c, 38d). As in the case of the CoCrAlY, depth of penetration was not significantly greater than that expected from SO_3 alone.

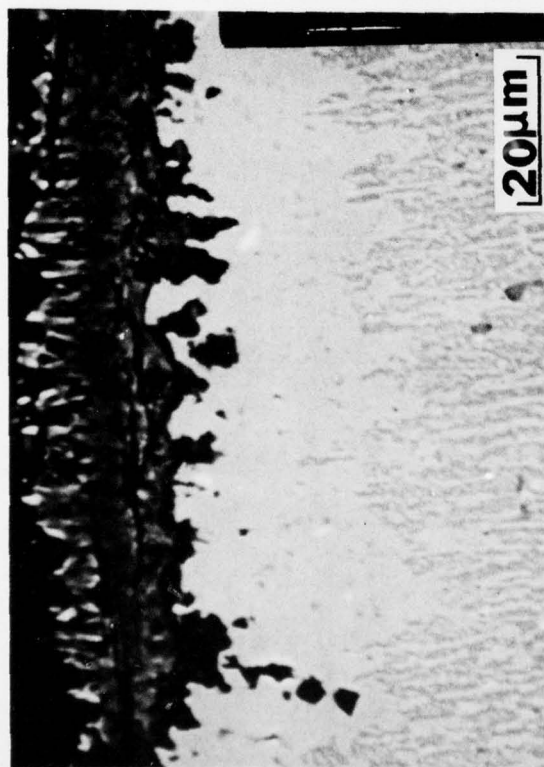
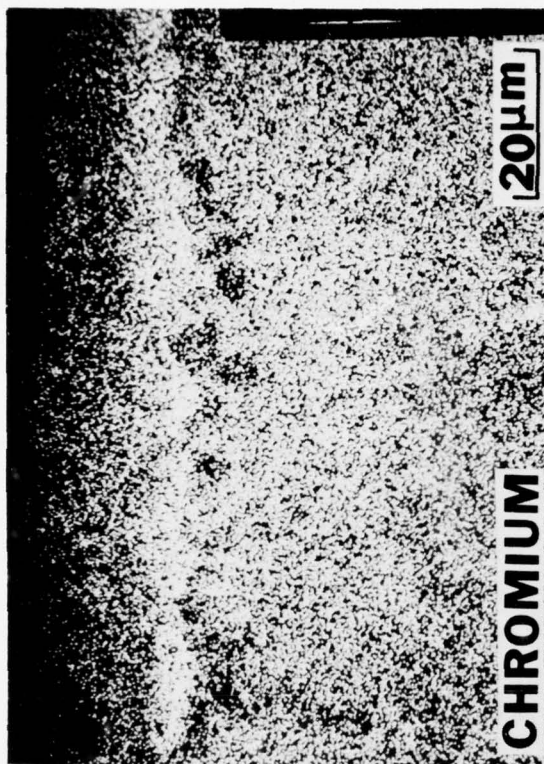
Figure 39. Typical microstructure, depth of attack, and element distribution (Cr, Al, and S) of CoCrAlY coating exposed for 100 hours at 899C with $\text{pSO}_3 = 0.0007$ atm and 30 ppm NaCl vapor.

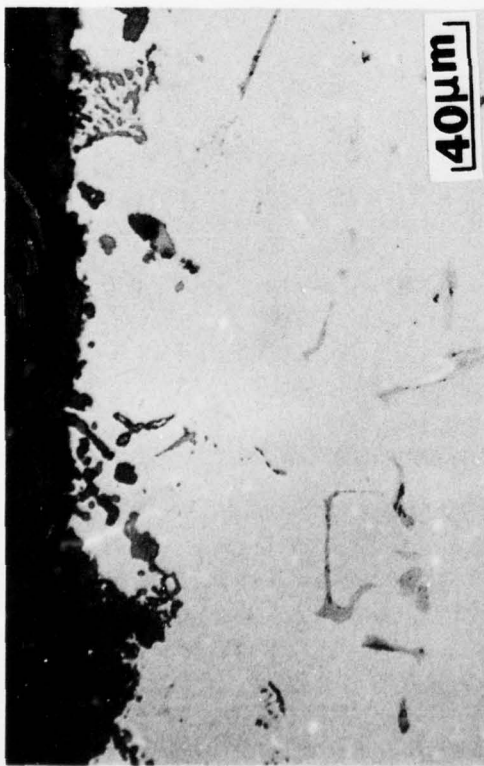
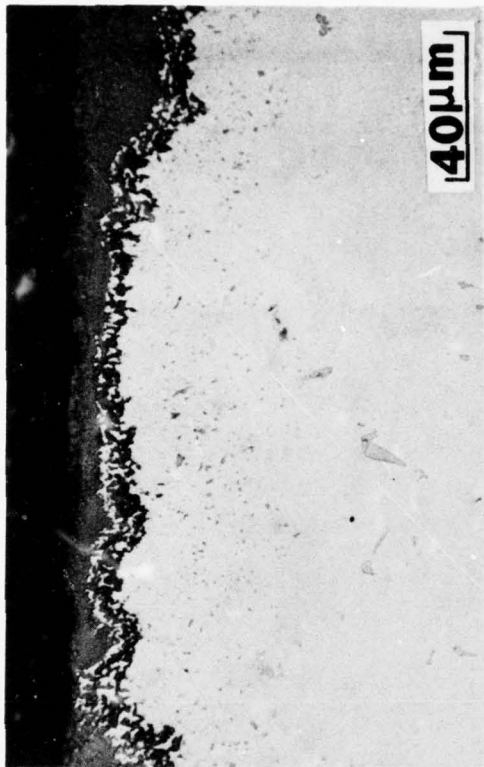
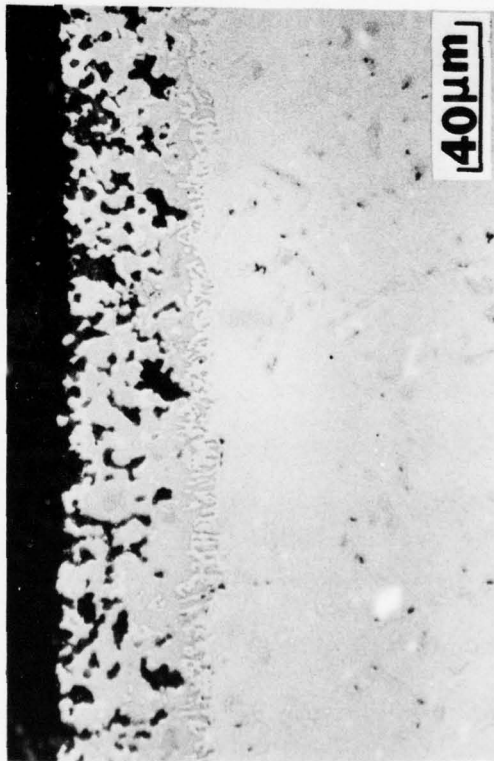
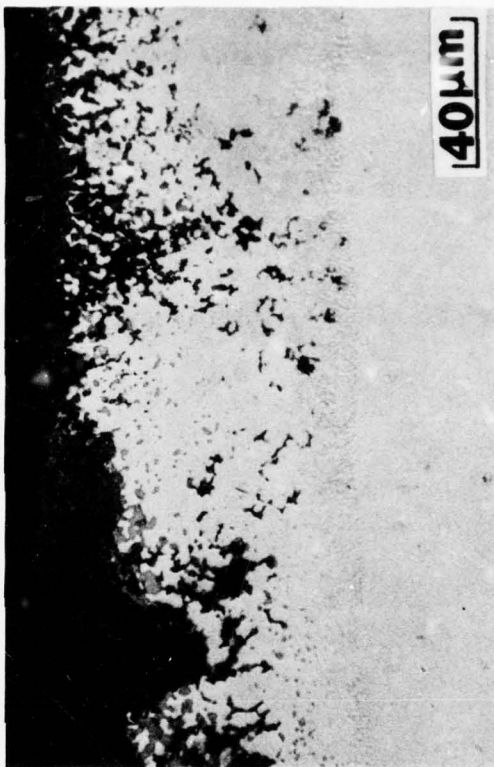
40a. Uncoated Mar-M509

40b. Uncoated IN 792

40c. Mar-M509/FWA 28 aluminide

40d. IN 792/FWA 273 aluminide

Figure 40. Uncoated and aluminized alloys tested concurrently with the CoCrAlY coating of Fig. 39 (i.e. 100 hours at 899C, $P_{SO_3} = 0.0007$ atm, 30 ppm NaCl vapor).

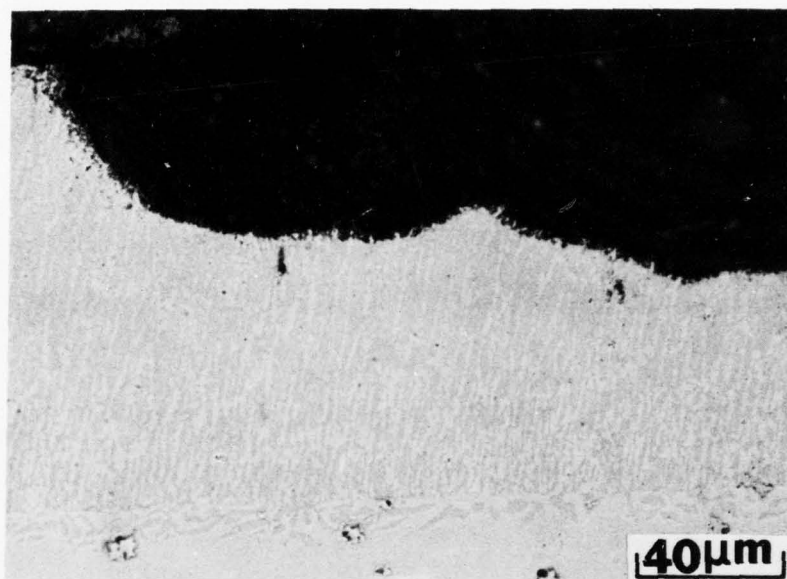
a. Na_2SO_4 - 50m% CoSO_4 salt deposit

b. Na_2SO_4 - 50m% ZnSO_4 salt deposit

Figure 41. Typical depth and microstructure of hot corrosion attack produced by 100-hour cyclic exposure of CoCrAlY at 704C with $p_{\text{SO}_3} = 0.0007$ atm and 30 ppm NaCl vapor.

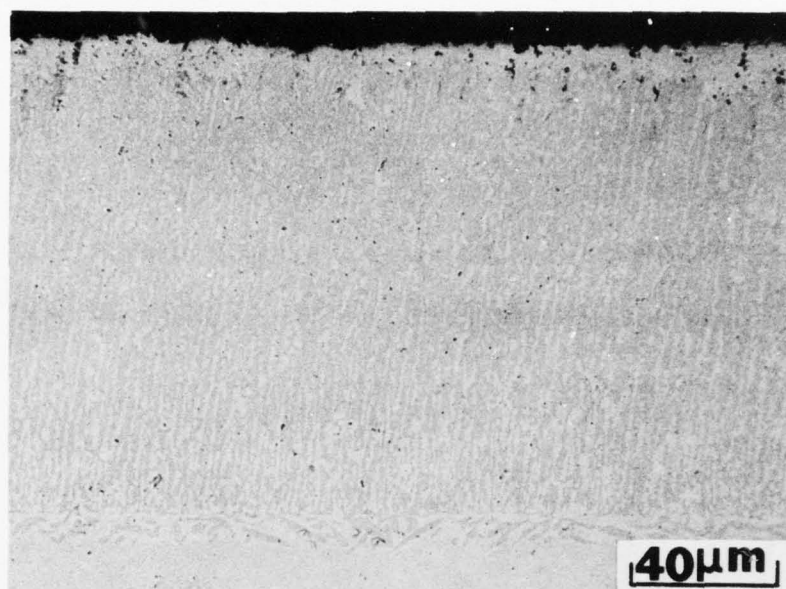
Figure 42. Negligible microstructural degradation of CoCrAlY coating covered with a 2 mg/cm^2 mixture of Na_2SO_4 and CoO and exposed for 100 hours concurrently with the specimens of Fig. 41 (704°C , $p_{\text{SO}_3} = 0.0007 \text{ atm}$, 30 ppm NaCl vapor).

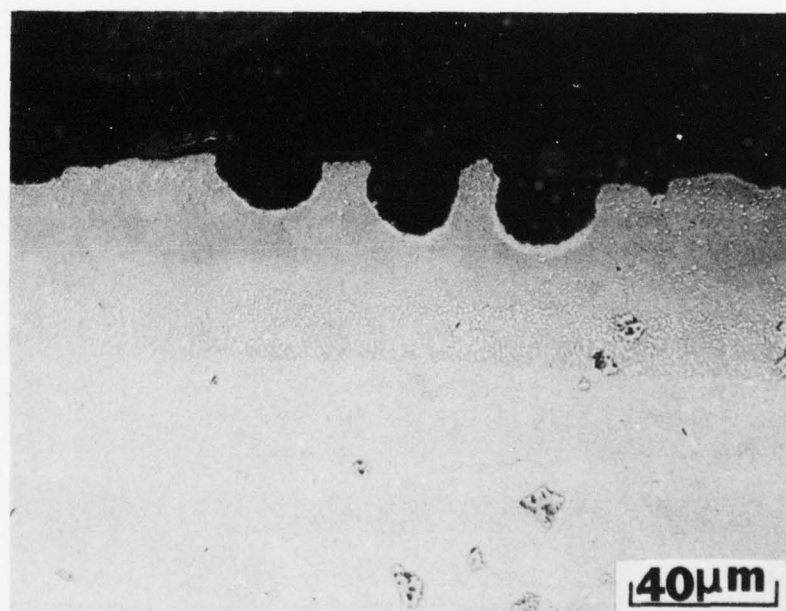
Figure 43. Nodular attack of PWA 273 Ni-base aluminide coating produced by a salt deposit of Na_2SO_4 - 50m% CoSO_4 and cyclic exposure for 100 hours at 704°C , $p_{\text{SO}_3} = 0.0007 \text{ atm}$, and 30 ppm NaCl vapor.

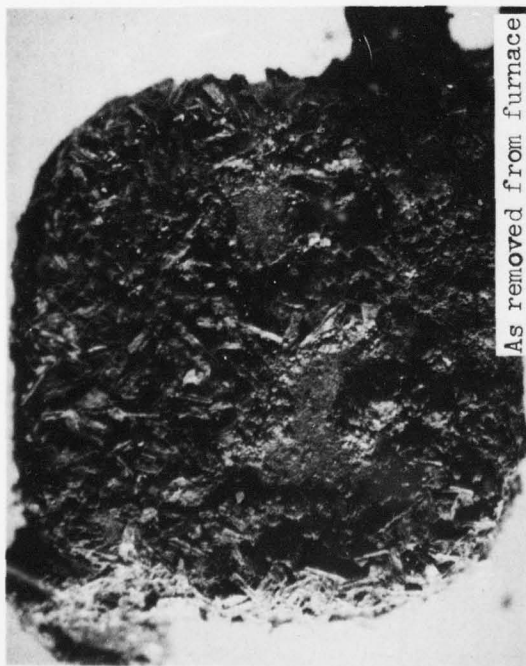
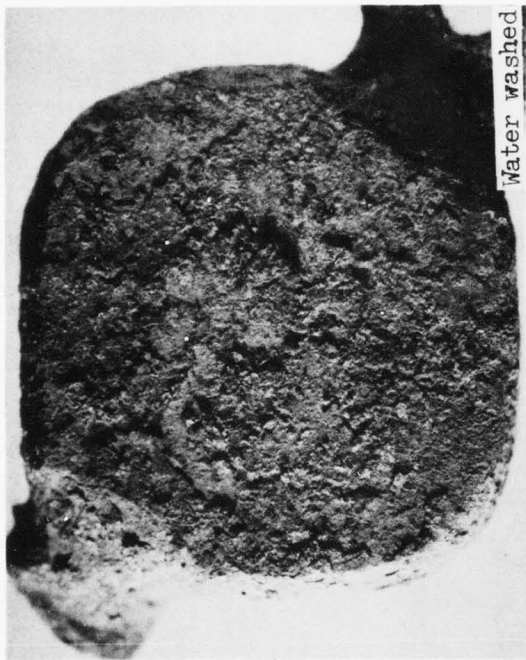
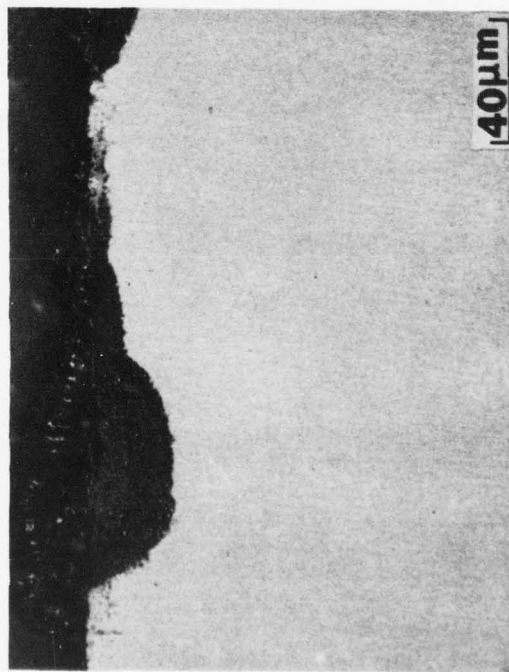
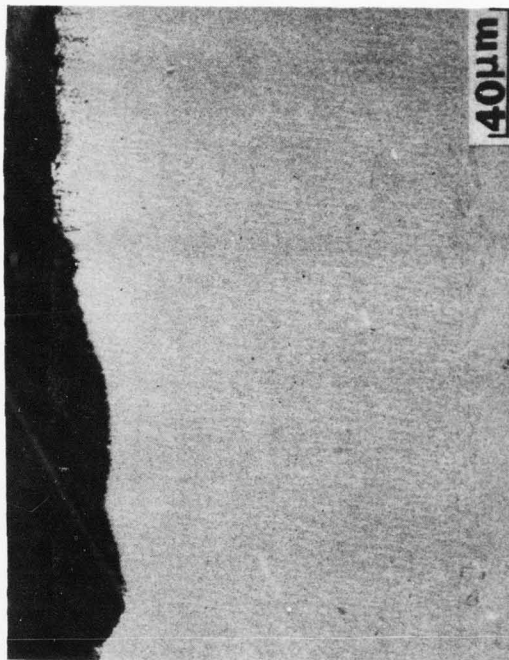
As removed from furnace

Water washed

Figure 44. Surface condition and typical depth of attack of CoCrAlY coating produced by 5 mg/cm² salt deposit exposed for 20 hours at 704°C with $\text{PSO}_3 = 0.0007$ and 30 ppm NaCl vapor.

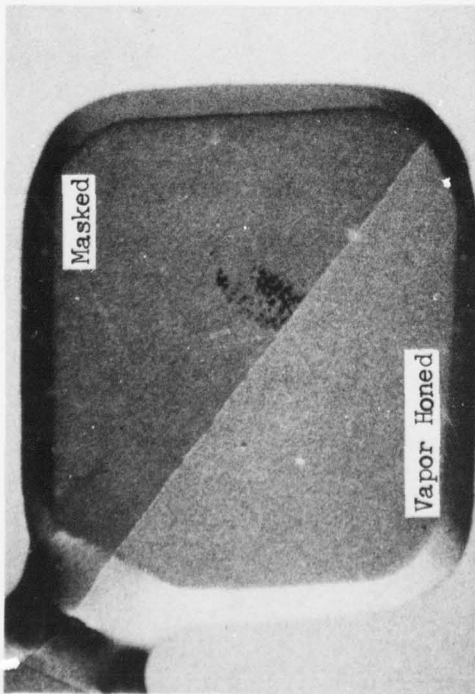
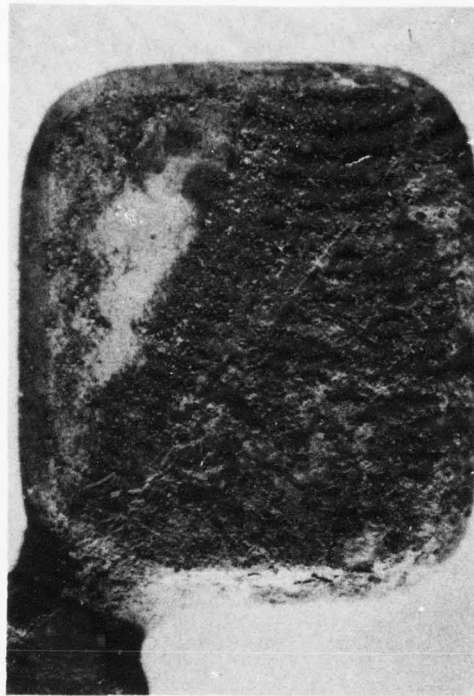
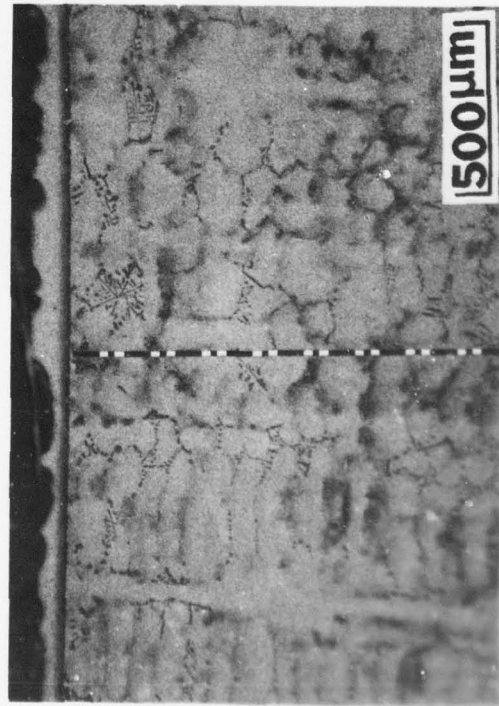
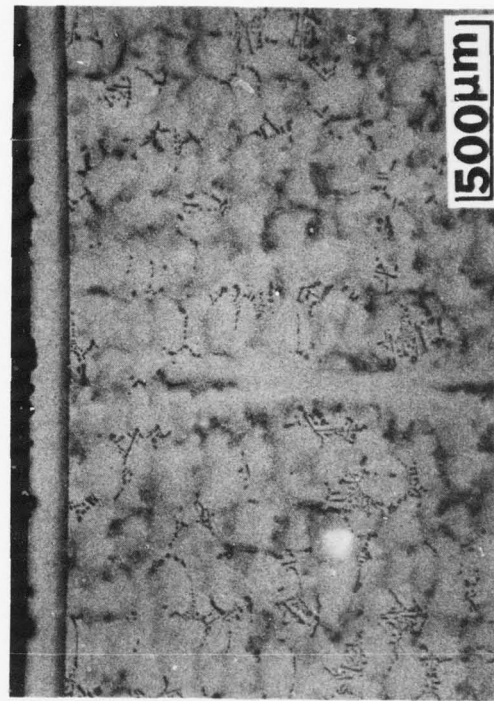
Pre-test condition

Exposed 20 hours; 704C, $\text{pSO}_3 = 0.0007 \text{ atm}$

Transition between masked and vapor honed areas

Typical degradation of masked area

Figure 16. CoCrAlY specimen prepared by masking and vapor honing as described in text.

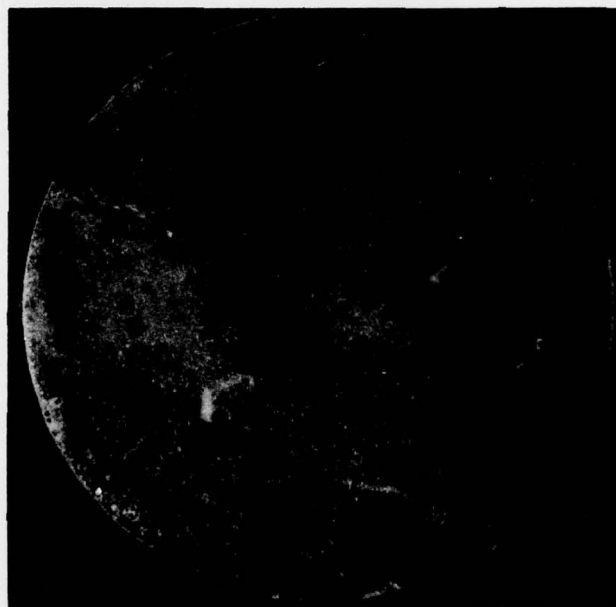
a. 100% Na_2SO_4

b. Na_2SO_4 - 50m% CoSO_4

Figure 46. Deposits of 100% Na_2SO_4 and Na_2SO_4 - 50m% CoSO_4 exposed 20 hours at 70°C with $p_{\text{SO}_3} = 0.0007$ atm.

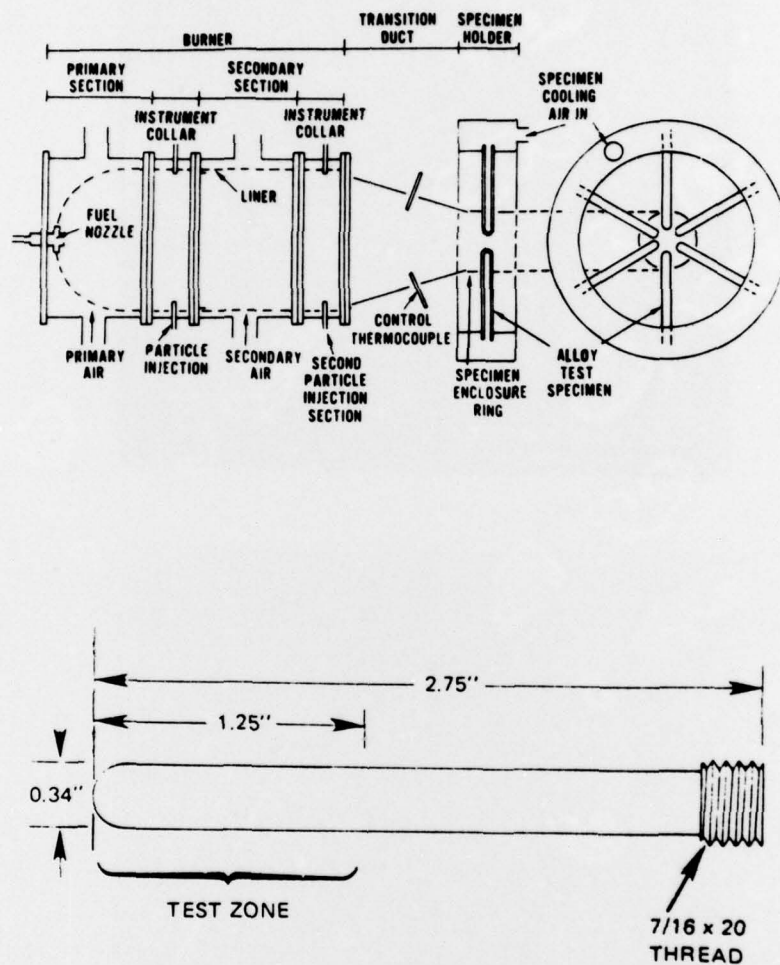
Figure 47. Schematic diagram of ducted burner rig and cylindrical test specimen used for hot corrosion - salt deposition rate dependence tests. (Aqueous salt solution was injected into the primary combustor through hypodermic tubing near the fuel nozzle; provision for particle injection and specimen cooling were not utilized on this program.)

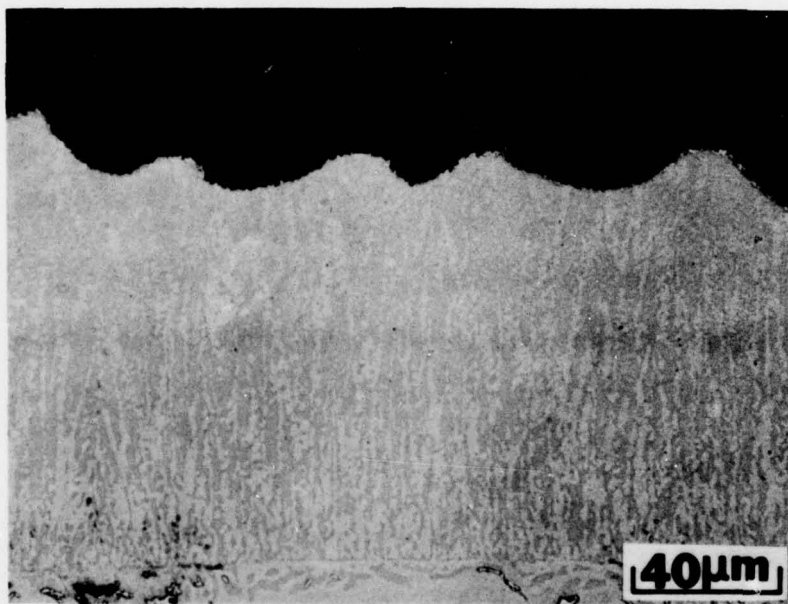
Figure 48. Nodular attack developed in preliminary burner rig test with ASTM sea salt and SO_2 gas mixed with the primary air. Exposure time = 26 hours at 704°C , calculated SO_3 pressure = 5.3×10^{-7} atm.

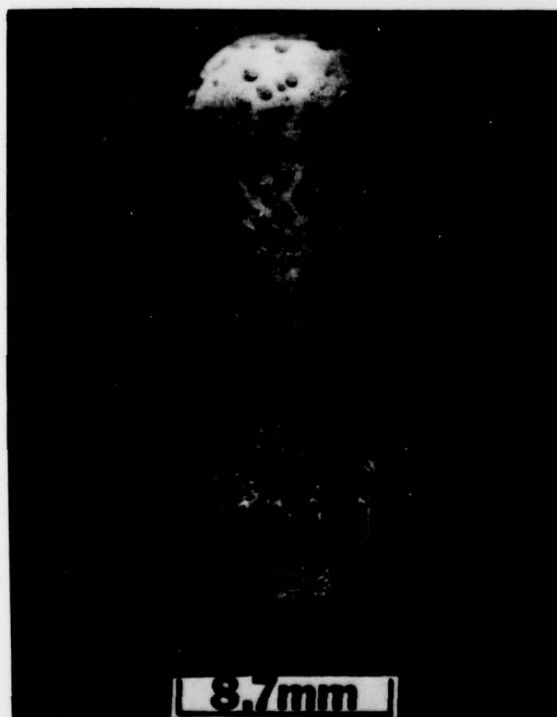
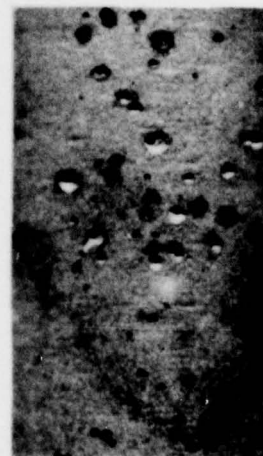
Figure 49. Salt deposit and oxide mounds (inset: pits after removal of mounds) on CoCrAlY specimen exposed 10.5 hours to Na_2SO_4 - 50m% MgSO_4 salt. Calculated SO_3 pressure = 5×10^{-5} atm.

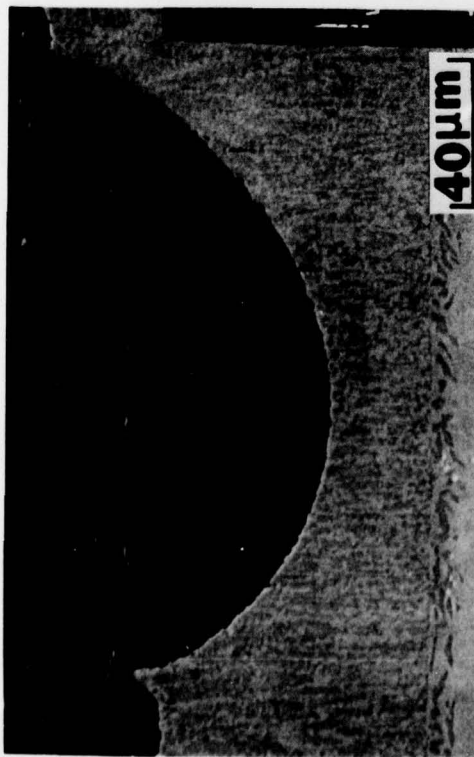
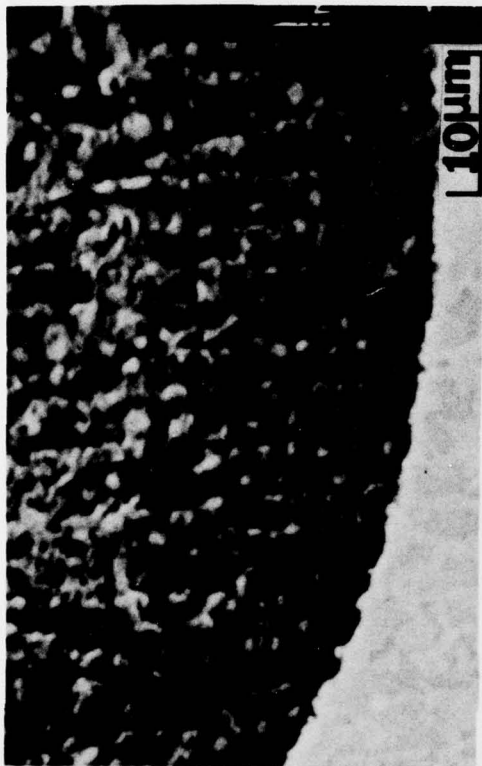
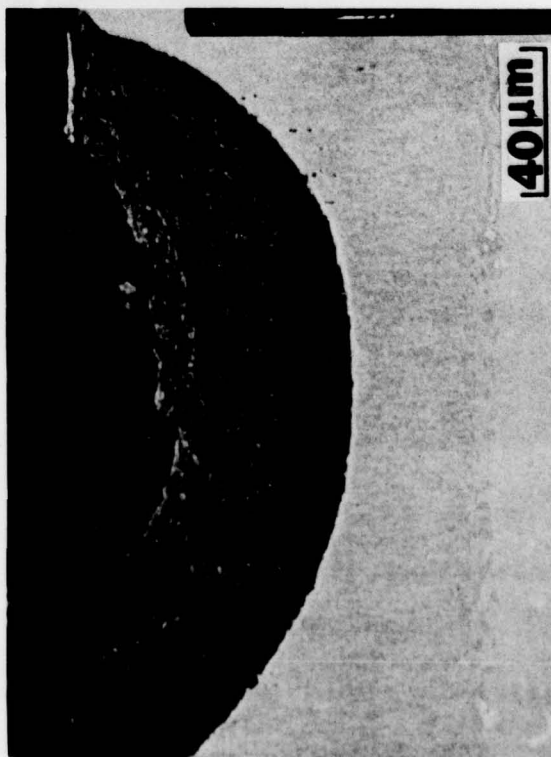
Exposure to show coating microstructure

Ghost image in scale

Exposure to show scale

Sulfur X-rays of above area

Figure 50. Depth and microstructure of pitting attack, as shown by sectioning through the sample of Fig. 49.
